ENERGY DISSIPATORS FOR FLUMES AND CULVERTS

EQUIPMENT DEVELOPMENT AND TEST REPORT 7700-12

Ted L. Pickett, Mechanical Engineer

APRIL 1977

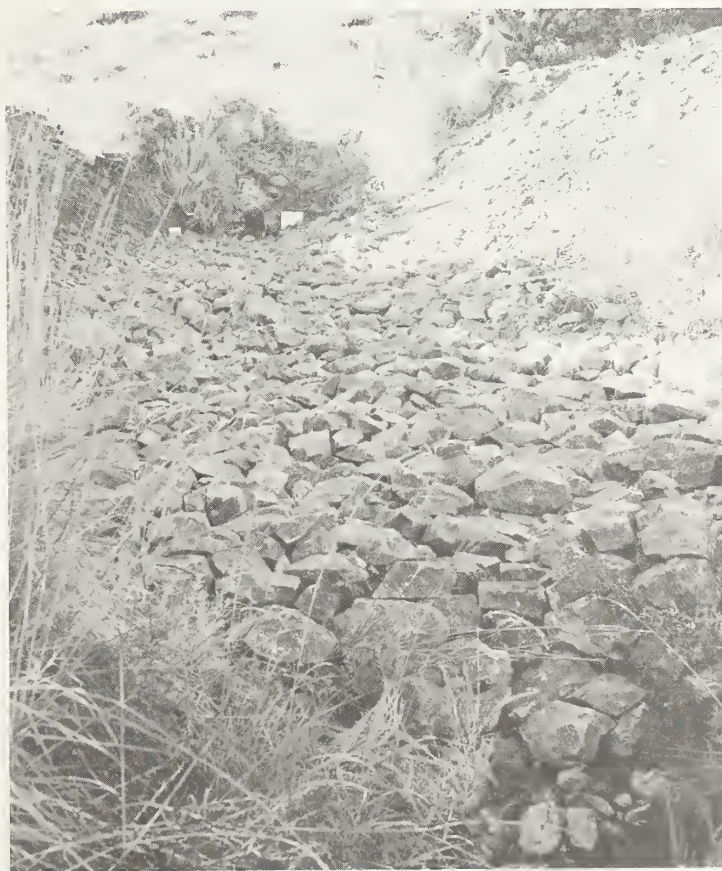
Figure 1. Typical rip-rap site, Toiyabe National Forest, Calif.

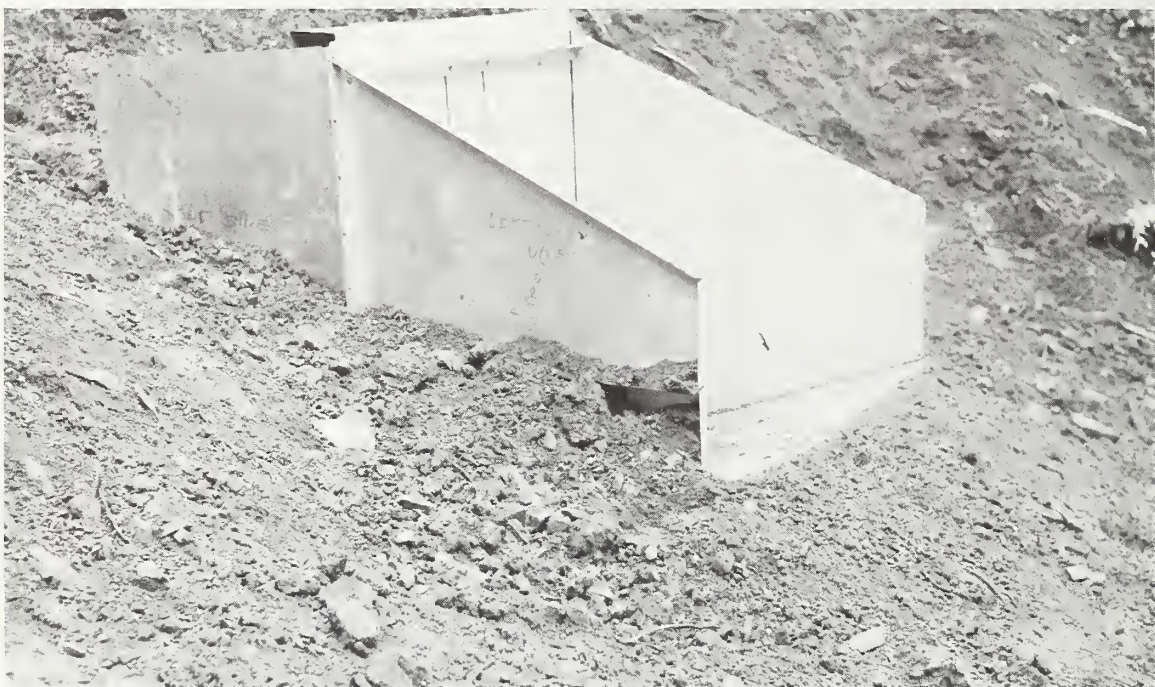
Figure 3. Dissipator installed at "severe" location.

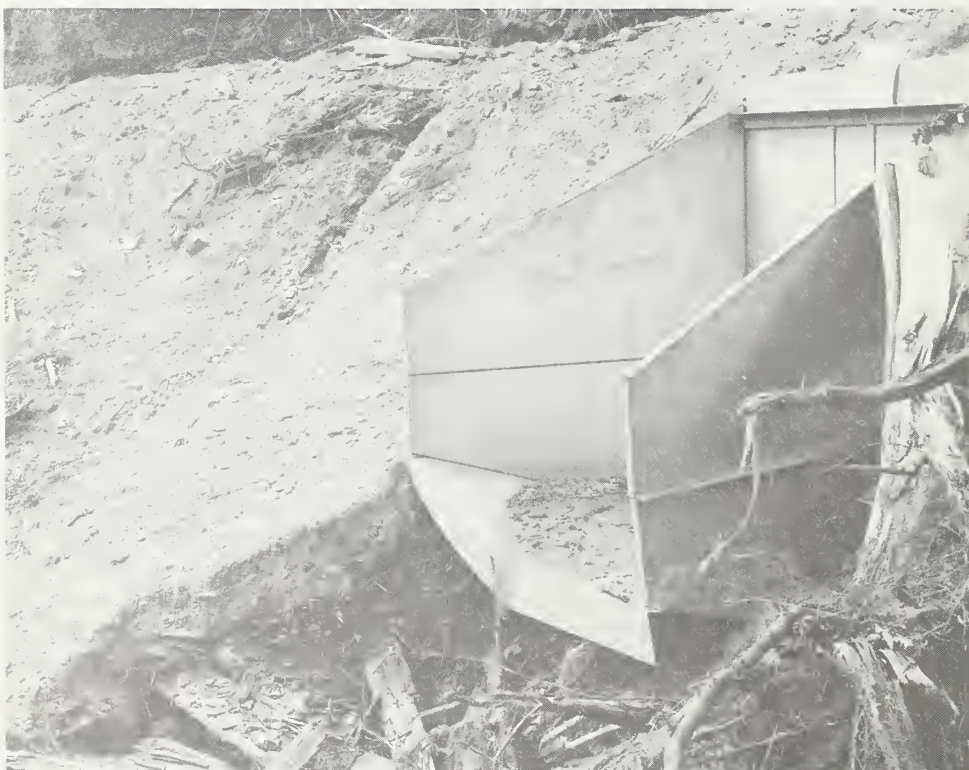
Figure 4. "Severe" site shows signs of much erosion.

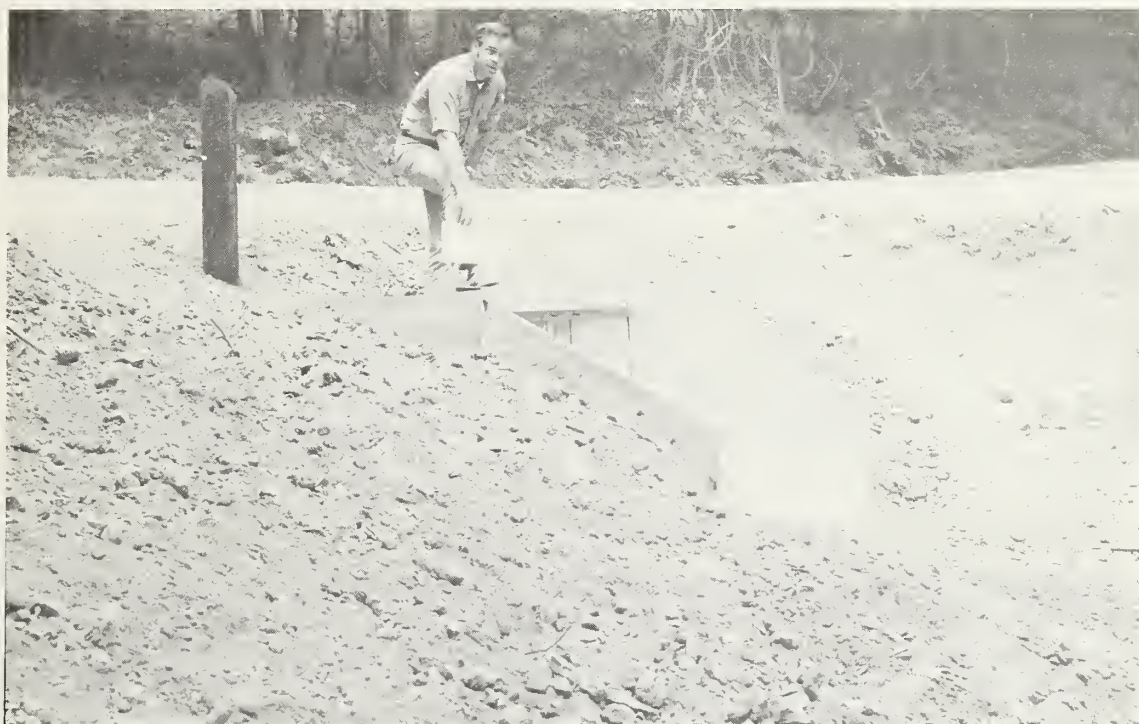
Figure 5. Dissipator right after being installed at relatively "stable" site.

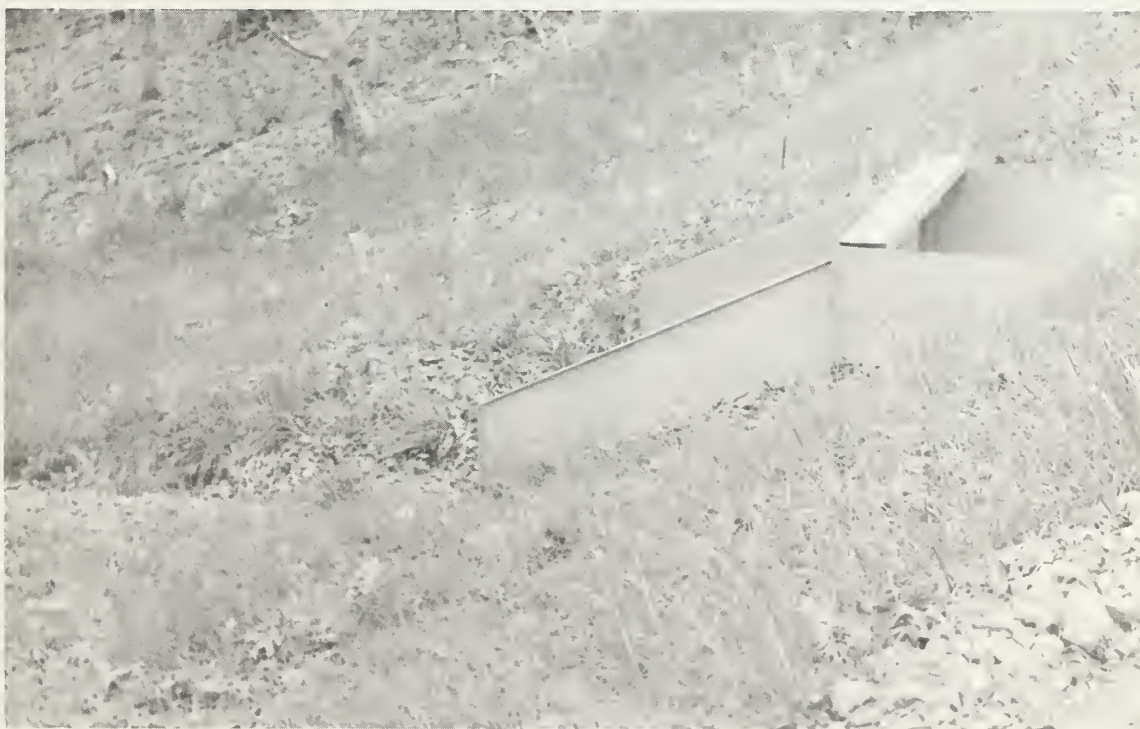
Figure 6. Dissipator has successfully stemmed erosion at the "stable" site.
